# SLAT REPAIR AND REPLACEMENT

**The Field Guide to Slat Repair and Replacement**

## CONCRETE SLATTED FLOORING

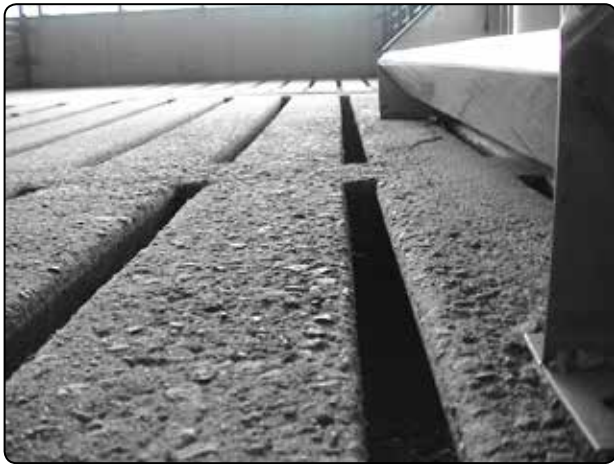
The first areas to exhibit significant wear will be around the feeders and waterers. These areas may show damage in as little time as six months. This wear is expected and does not indicate poorly made or inferior slats.

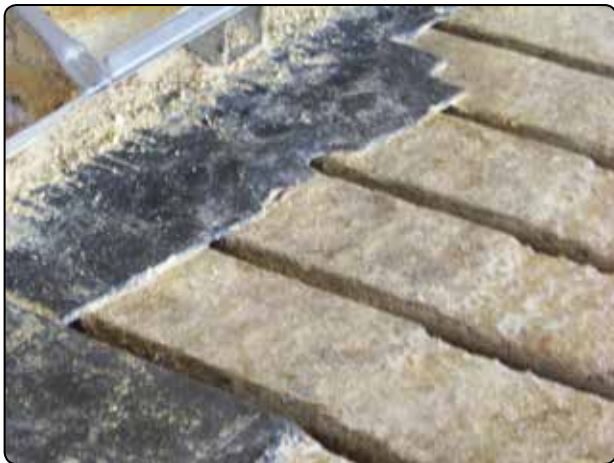
A conventional method of preventing this damage is to cover the slats around feeders with a plastic mat. While this does protect the slats directly under the mat, it only moves the problem to the edge of the mats. Water, manure and feed salt gather on the mat surface and run off the mat edge damaging the concrete slats. The pigs can also chew and damage the plastic mat. The same limitations occur when a concrete feeder pad is used; the corrosion is moved to the edges, and in this case, the concrete pad is subject to the same wear and deterioration as the slats.

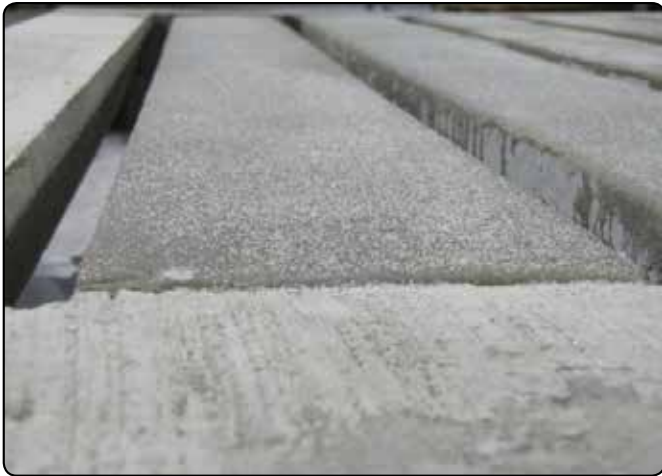
Vanberg Coating's Armor-Rock is an excellent product to create an improved "slat mat." Armor-Rock is a unique blend of epoxy resin and aggregates providing an exceptionally tough wearing and chemical resistant overlay.

Armor-Rock allows slats to drain properly preventing the spread of corrosive liquids.

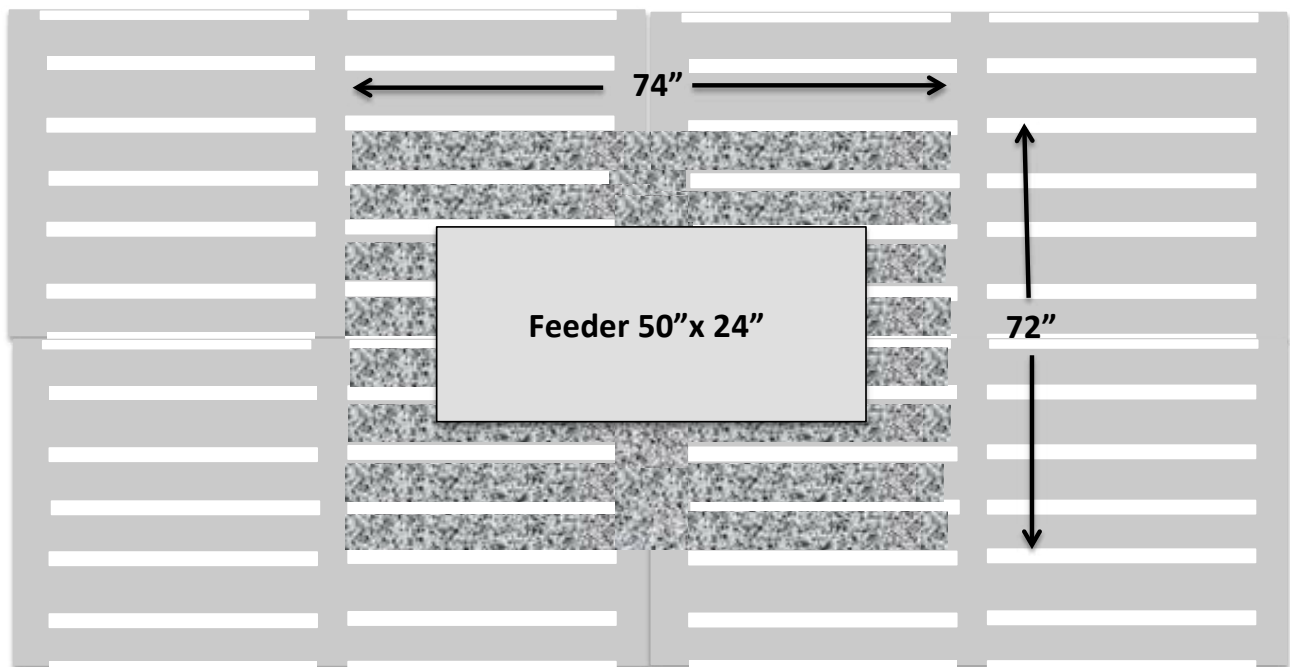
Typical dimensions for the coated area would be 12" longer than the feeder and 24" out from the feed trough on each side. For example, Hog Slat's 4-hole Wean to Finish Feeder measures 50" long by 24" wide. The coated area for the slats under this feeder would be 74" long by 72" wide.

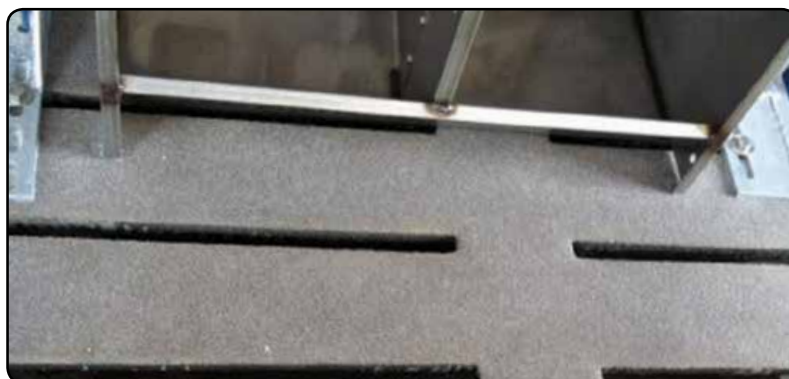
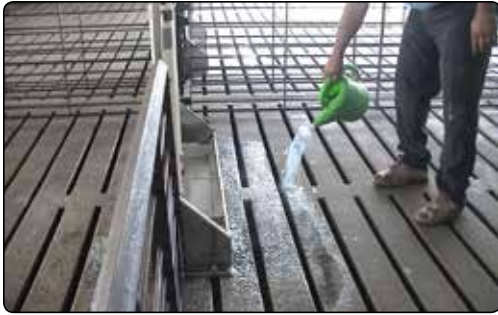
The application begins by masking off the borders of the area with duct tape and cutting a 1/4" x 1/4" groove along the perimeter for the epoxy to flow into. Next, the surface is prepared before coating. Uniformly apply Vanberg's Clean and Etch with a plastic sprinkler can and scrub in with a stiff broom. Allow acid to work for 5-10 minutes, or until the bubbling reaction ends. Rinse with water and allow the surface to dry completely.

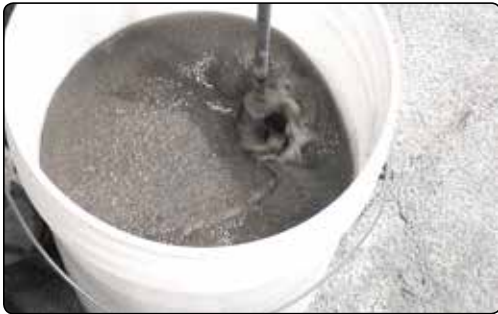
Combine the Armor-Rock epoxy resin and hardener products, mixing thoroughly. Incorporate Vanberg Admix, an aggregate mixture that adds additional strength and wear properties, into the epoxy liquids.

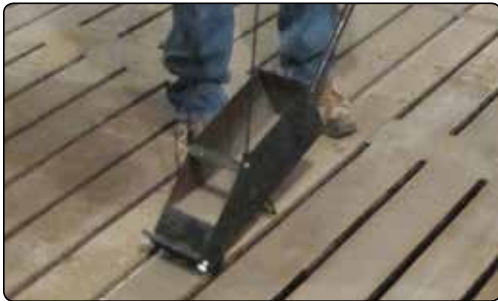
Apply to slat with Armor-Rock Applicator to a uniform depth of between 3/16" and 1/4". Or, pour the epoxy slurry as a bead down the slat center and spread with a Notched Squeegee to a uniform depth.

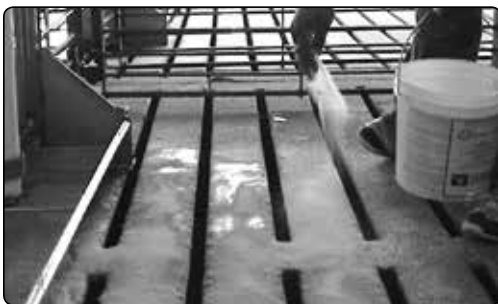
The next step is to broadcast Vanberg Topping Mix over the wet epoxy until the surface appears dry. Allow to cure for 6-8 hours.

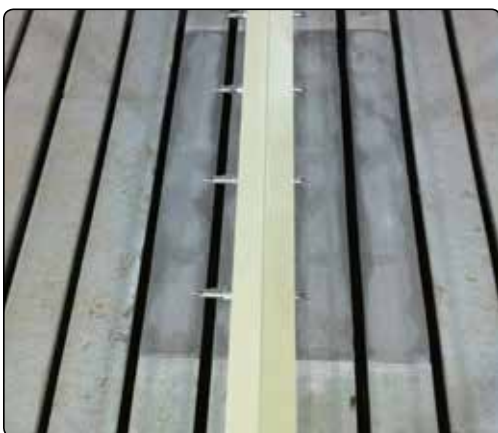
Areas around nipple drinkers and cup waterers also benefit from the same Armor-Rock coating. The suggested coverage is approximately 24" x 24" per water location.

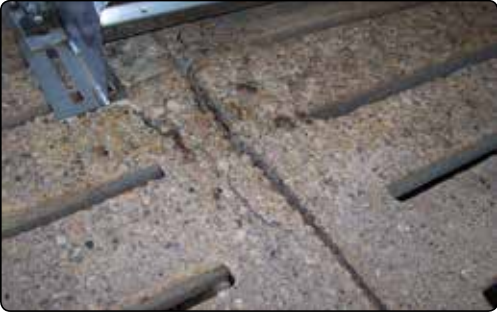
Moderate wear 1/4" to 1/2" deep. The surface is rough with lightly exposed aggregate showing.

Vanberg's Con-Korite is the product of choice for basic repairs. Formulated with Pure Cement Technology instead of a standard portland base, Con-Korite is a dense, abrasion resistant mortar that sets quickly without shrinking.

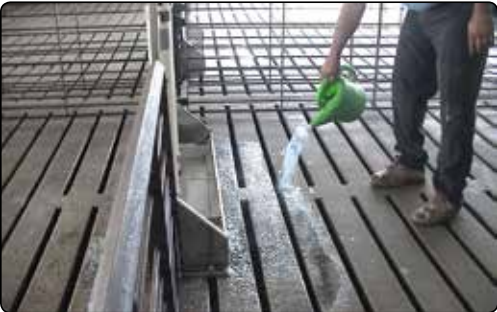
Clean and remove all debris and loose material from the damaged area. Uniformly apply Vanberg's Clean and Etch with a plastic sprinkler and scrub in with a stiff broom. Allow acid to work for 5-10 minutes, or until the bubbling reaction ends. Rinse with water.

Prime repair area by brushing with KB25 Acrylic Resin to improve bonding.

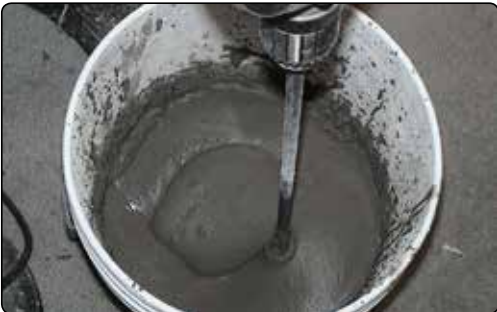
Add 3-4 qt. of Con-Korite to 1 qt. of KB25 and blend into a uniform mixture.

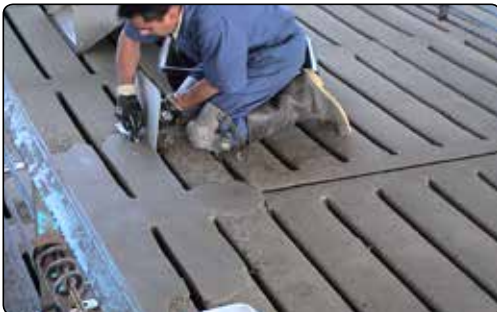
Place mix on prepared surface and smooth to desired finish with a trowel.

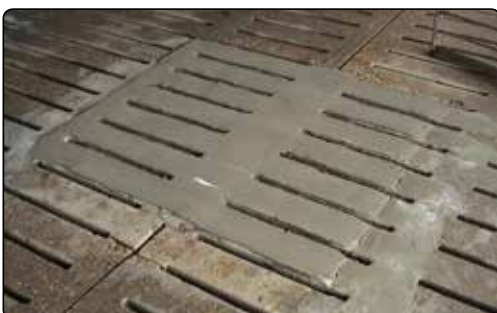
After rebuilding them to their original profile, slats near waterers and feeder will benefit from a protective layer of Armor-Rock. If Con-Korite will be coated with Armor-Rock create a gritty surface by embedding sand into the surface.

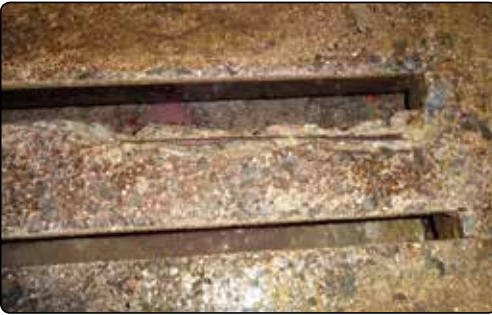
Common Level 3 damage includes mechanical breakage to a slat edge caused when installing gating or other equipment. The slat opening becomes wide enough to allow pig's legs to become caught. Rebuilding the slat edge restores the correct gap width and reduces pig injury.

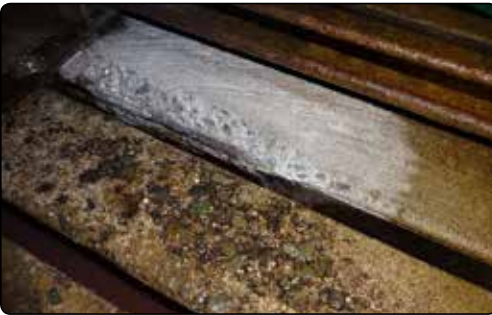
Clean and remove all debris and loose material from damaged areas. Prime slat edges by brushing with KB25 Acrylic Resin to improve bonding.

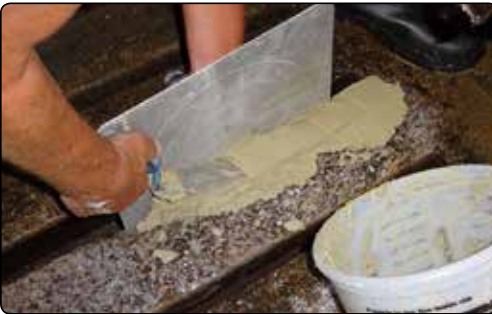
Place Con-Korite mortar over primed surface shortly after mixing. Shape with trowel and/or mud hawk to form new slat edge. For the most durable repair, wrap the mortar completely over the top of the slat.

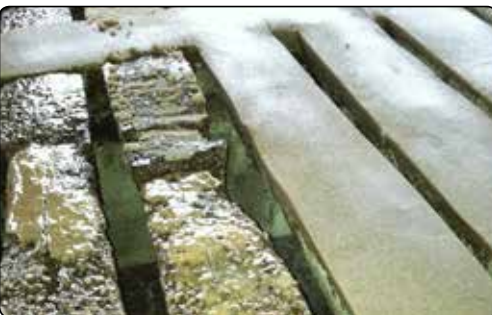
Armor-Stone Epoxy Mortar is the most durable product available for this type of repair. This specialty mortar combination of Armorcoat epoxy and sand is easily shaped to repair the slat edge profile.

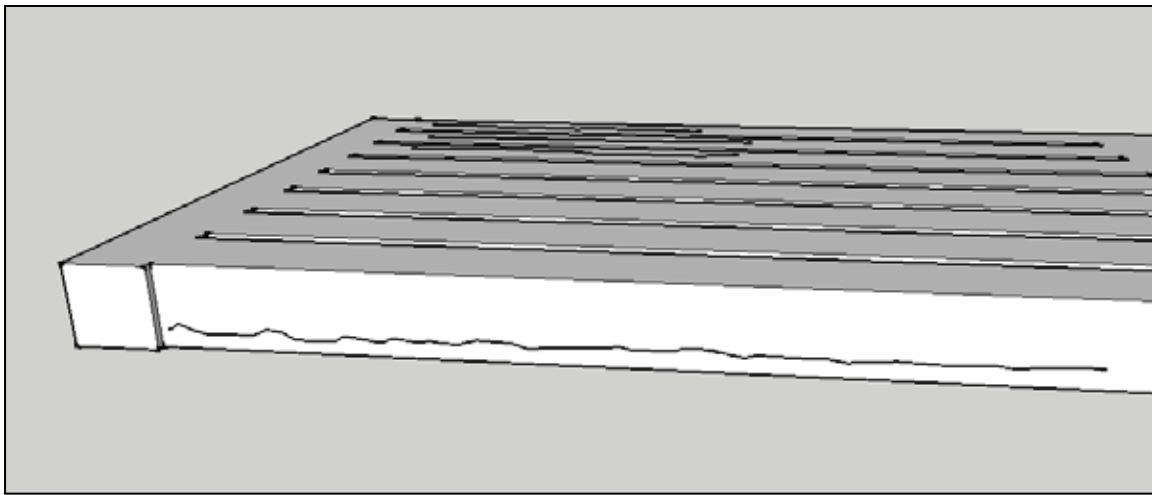
One common flaw occurs as a crack roughly two inches above the slat base. Moisture penetrates through the crack causing the rebar to rust and swell, damaging the concrete on the underside of the slat. It is almost impossible to repair this damage and the slat should be replaced.

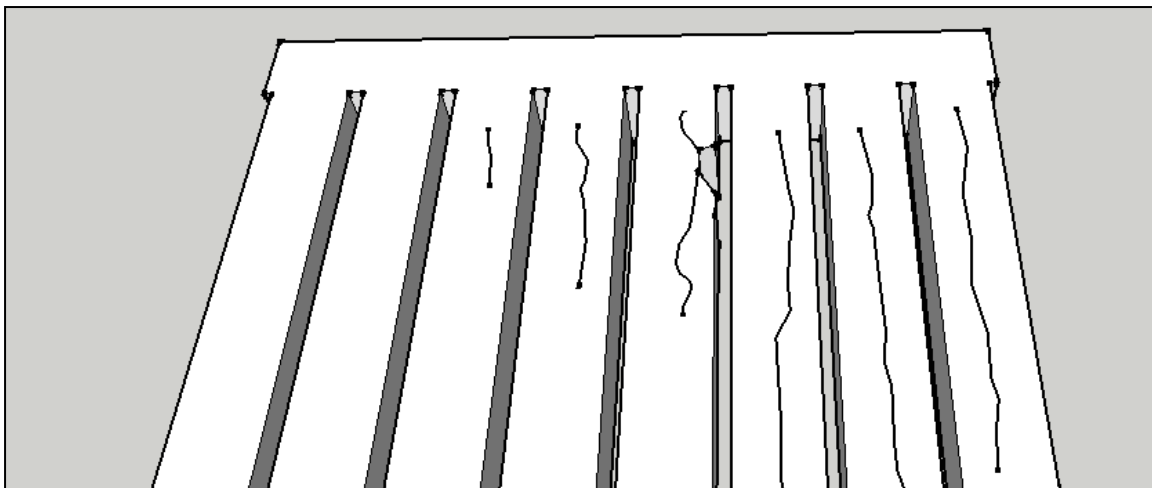
A second common flaw appears as cracks in the top surface of the individual slat. Applying an epoxy-based repair product such as Armor-Rock will arrest further damage and prevent moisture from reaching the rebar.

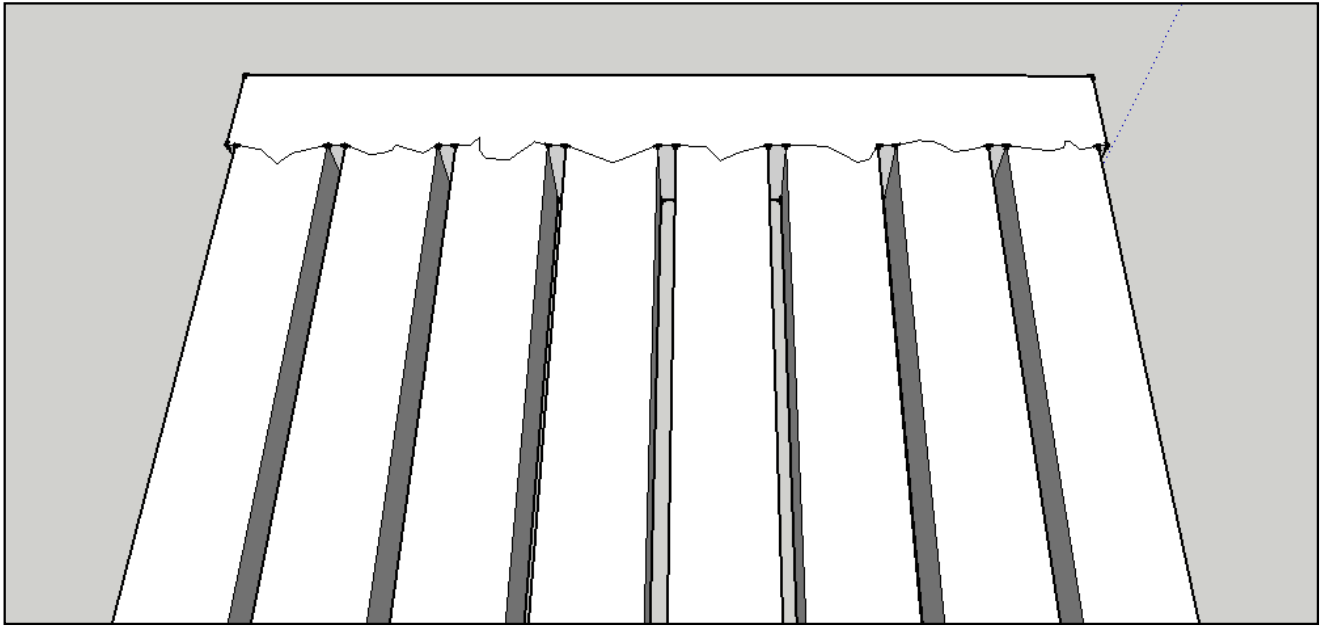
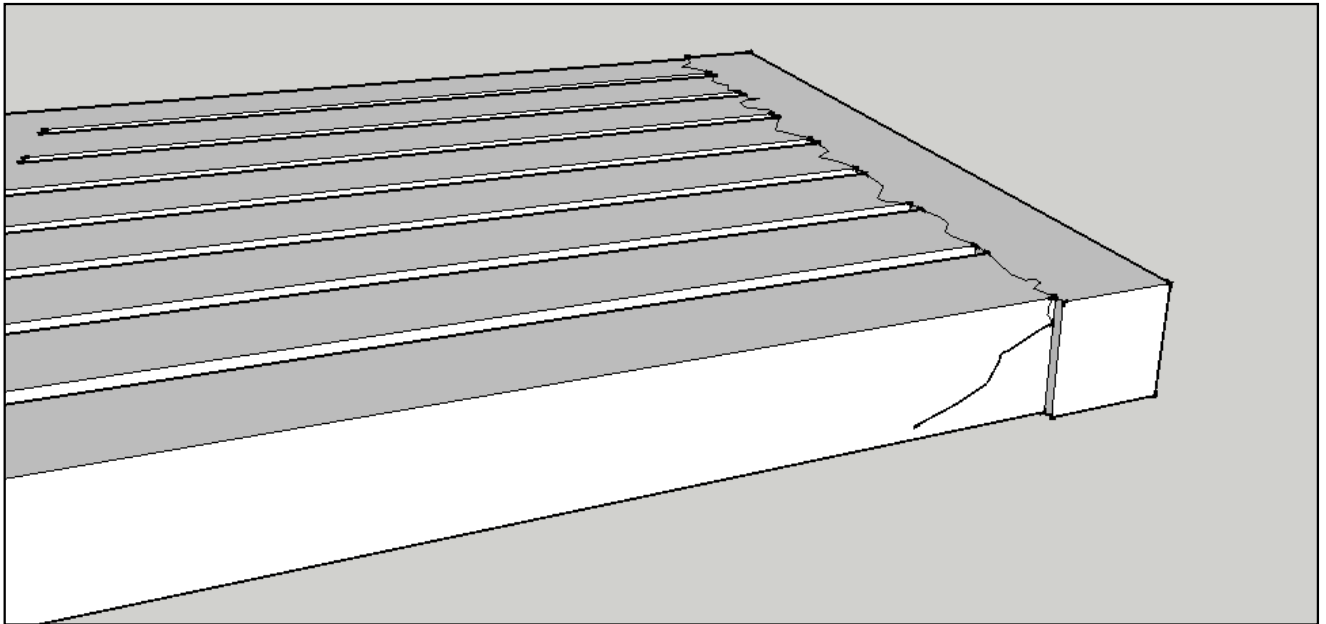
Surface cracks appearing where the individual slats meet the support webbing at the end or middle of the gang. Cracks in this area are common and are not usually a structural problem unless they become wider allowing moisture to reach the bottom load bearing rebar.

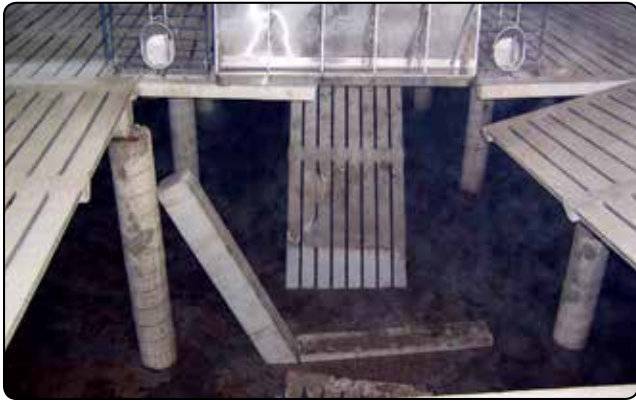
Pay particular attention to the support beams under the slats. According to slat replacement specialists at Altenburg Construction beams are many times a bigger cause for concern than the slats themselves. Deterioration of support beams is the cause of most catastrophic slat failures.

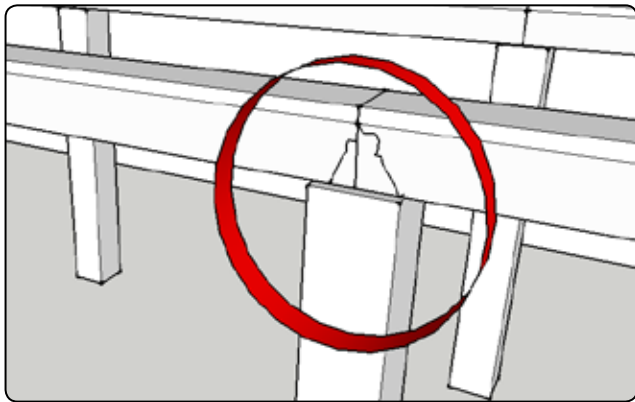
As they age, beams tend to develop cracks in the areas above the columns. Moisture seeps through the crack reaching the bottom support causing the rebar to rust.

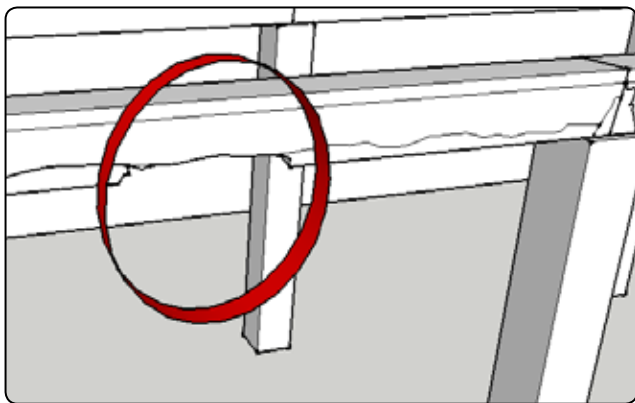
The rusting metal expands breaking the concrete causing the lower portion of the beam to fall off. A dangerous situation occurs as the structural integrity of the support lintel is compromised.

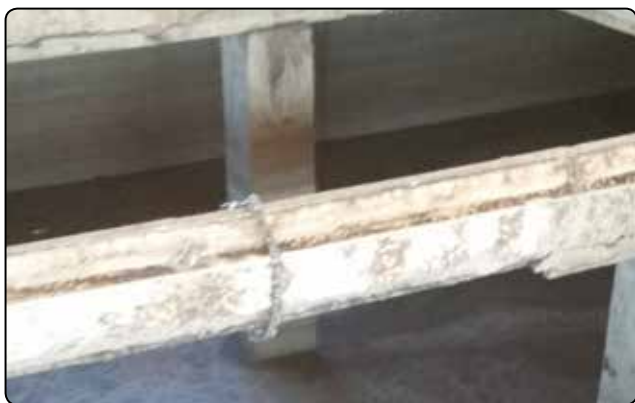
Deteriorated beams shown with slats removed. Note the deep cracking, indicating damage to interior support rods.

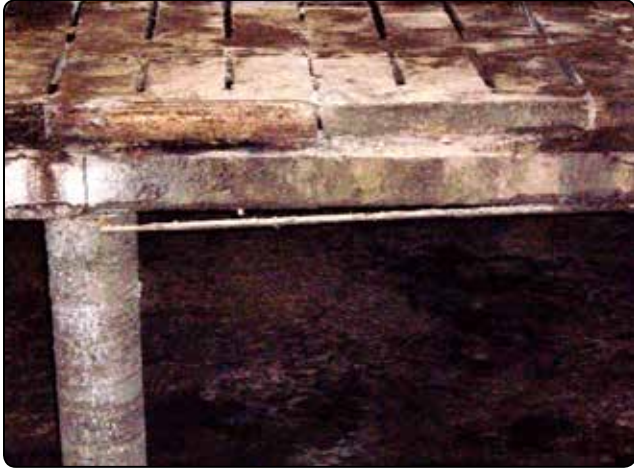
Another example of a beam with severe damage including exposed rebar.

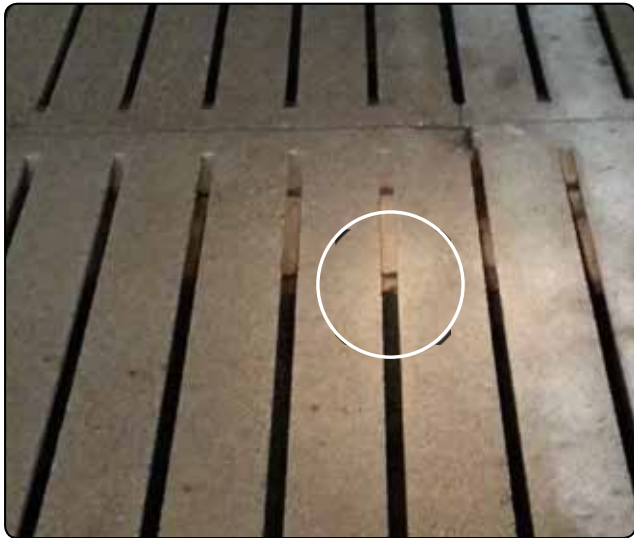
Carefully examine the support beams by shining a flashlight down through the slat openings. Look at both sides of the beams; occasionally a beam will appear to be structurally sound on one side while having rebar protruding out the opposite side.

Note circled area in the opposite photo. The bottom of the beam has started to crack and separate. The damage has occurred even though the slats appear to be in good condition.

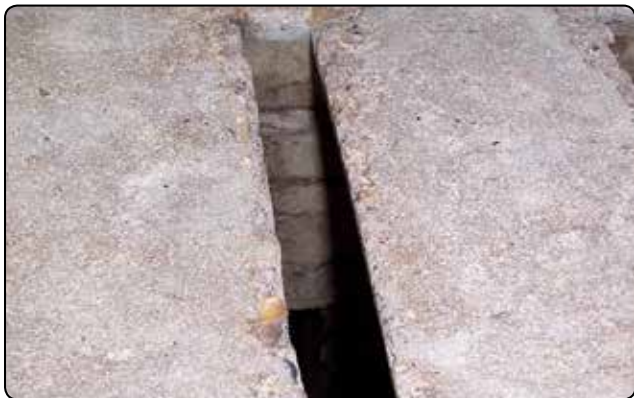
Close up view of a beam showing cracks and separation.

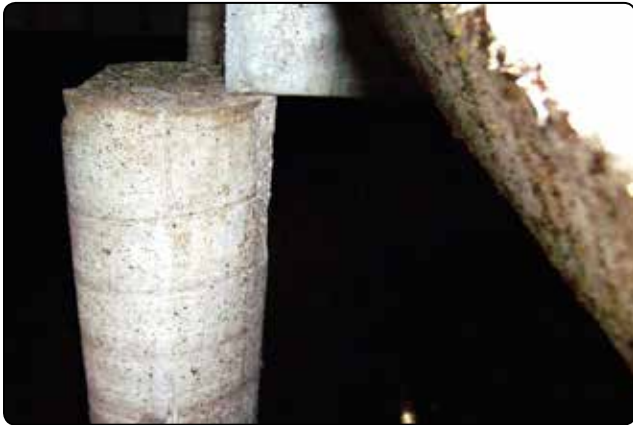
Another critical area is the amount of bearing surface a beam has on a column or end wall pocket. At least 3" of bearing surface should be present. Over time a building can shift, especially on the end walls allowing the beam to fall out of the pocket. When this condition is discovered the slats and beams must be removed and column added at the end wall.

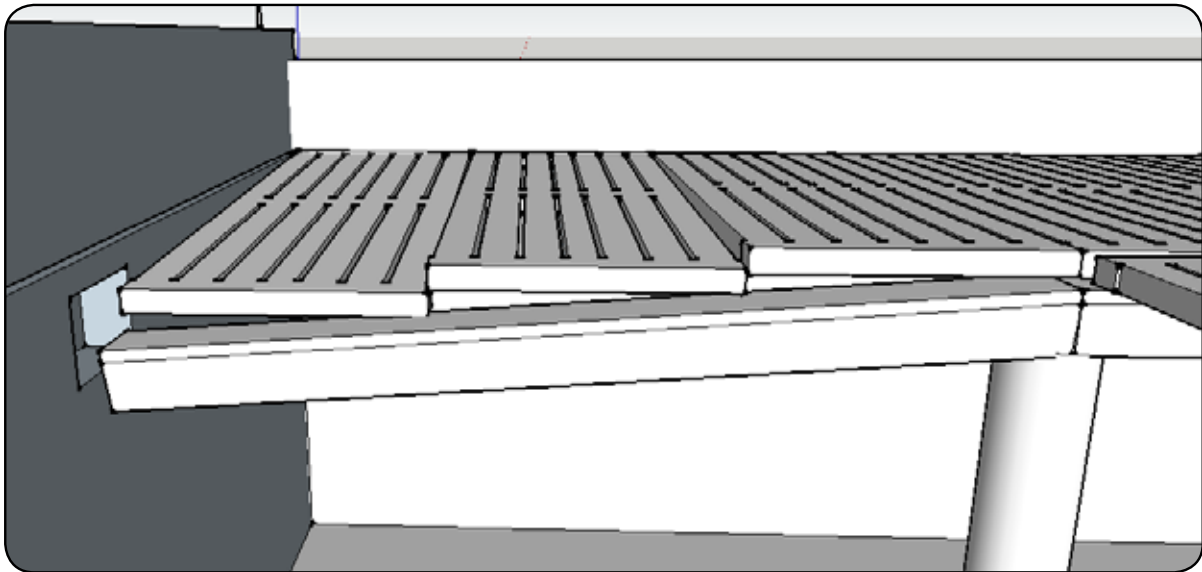
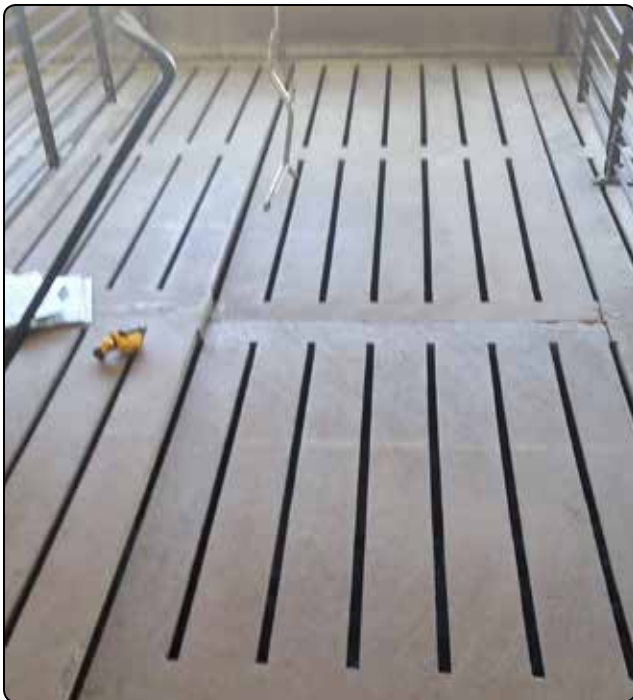
The appearance of uneven slats can be an indication of a beam starting to fall from a column or end wall pocket.

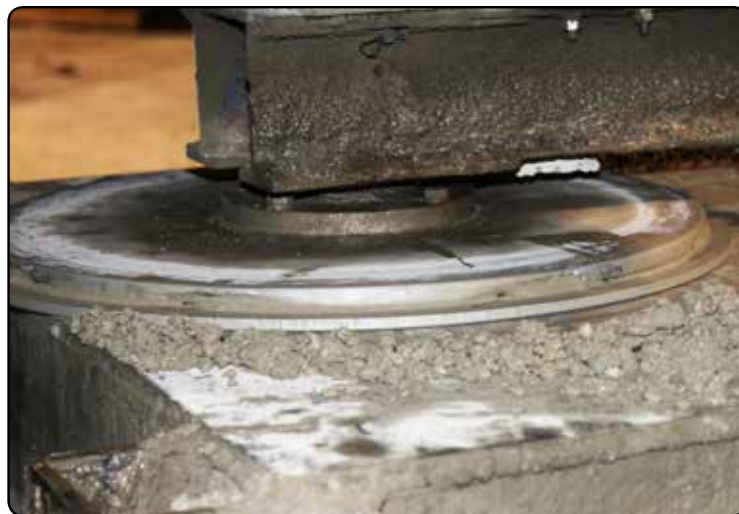
### *Machined Slat* (cross-section)

**Machined slats manufactured by Hog Slat are produced with a different process that eliminates the uneven surface found on hand cast slats. Automated Rotoscreeds "strike off" the mold creating a level, uniformly flat top that is easier for pigs to move across.**

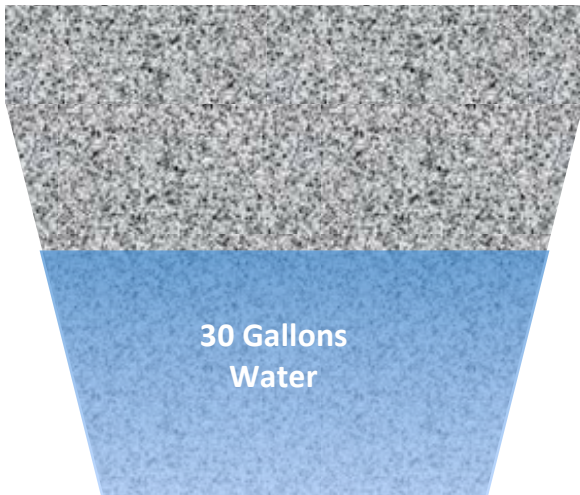
**Wet Cast Concrete**

**. 5 Cement- Water Ratio  
500 lbs. Cement**

**The water-cement ratio refers to the ratio of the water weight to the cement weight used in a concrete mix. A lower ratio leads to higher strength and durability but makes the mix difficult to work with and form. For this reason, most slats are produced with wet cast concrete using a water-cement ratio of 0.5. Hog Slat's machined slats are produced from dry cast concrete with a water-cement ratio of less than .39.**

**A cubic yard of wet cast concrete formulated with 500 pounds of cement contains 250 pounds of water, while a dry cast mix only contains 195 pounds. As the excess water leaves during the curing process, it creates microscopic pores that reduce the final strength of a slat. Compromised slat strength can lead to many problems down the road, including expensive repairs, equipment damage and injury to pigs and farm personnel.**

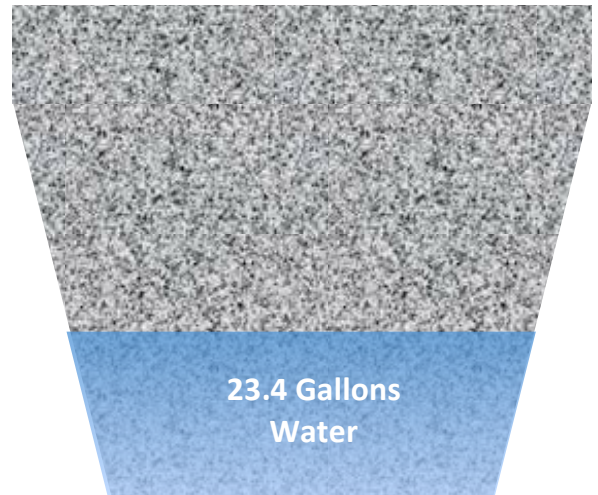
**Dry Cast Concrete**

**. 39 Cement- Water Ratio  
500 lbs. Cement**

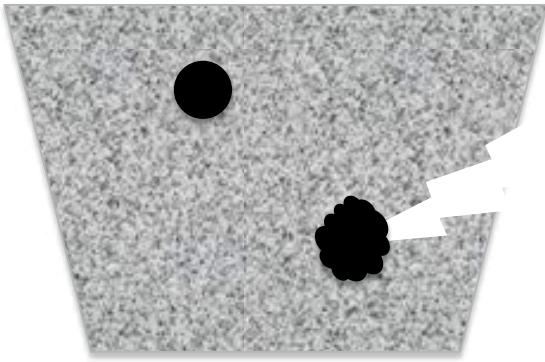
**Rebar placed too close to side can corrode causing concrete to crack and flake off.**

**Improper placement of reinforcing rods is a common cause of premature slat and beam damage. Individual rods placed too close to the side of a slat or beam can cause the rods to swell bursting or cracking the concrete. Hog Slat uses pre-welded steel mats to assure correct rod placement in each gang slat produced.**

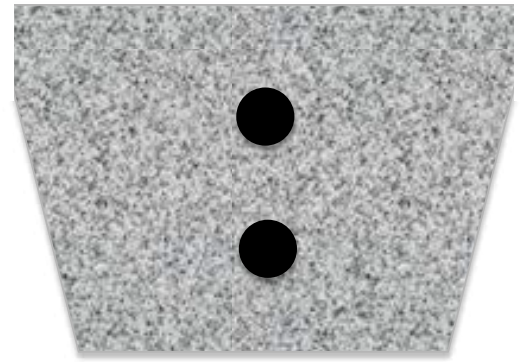
**Rod placement with welded mats is consistent and exact.**

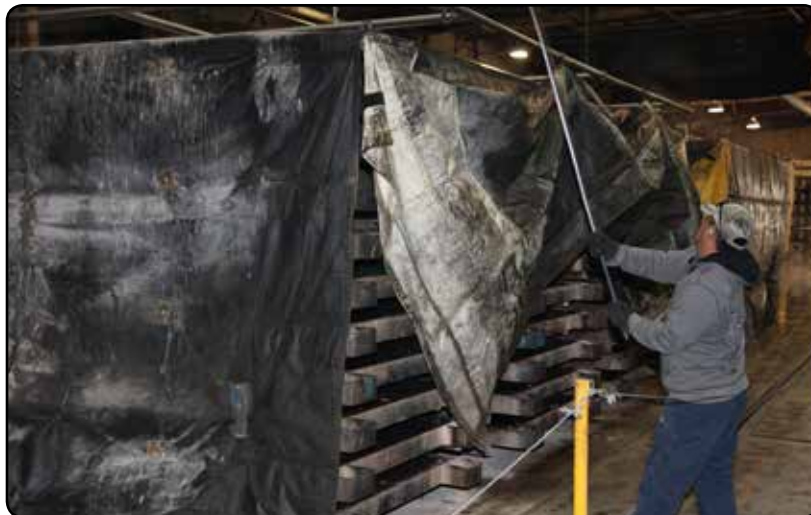
**After casting, Hog Slat steam cures slats in climate-controlled tents. Steam provides the heat necessary for accelerated curing and the moisture to prevent stress cracks and shrinkage. In only a few hours, we can harden slats that exceed 28-day strengths of typically cured concrete. Hot, dry weather or cold, wet conditions don't affect the quality of the slats delivered to your farm. It is important proper steam curing procedures are followed to ensure long-term durability of the slats. The rate of temperature gain and the maximum temperature in the curing chamber must be controlled and monitored using accepted industry guidelines and practices. Failure to do this can result in a shortened lifespan of the concrete slats due to delayed ettringite formation (DEF), a condition that leads to early deterioration of the concrete when exposed to an environment similar to that found in a hog barn.**
